08 Civ 5220 (DLC) (FM)

DECLARATION OF STEPHEN SPAULDING

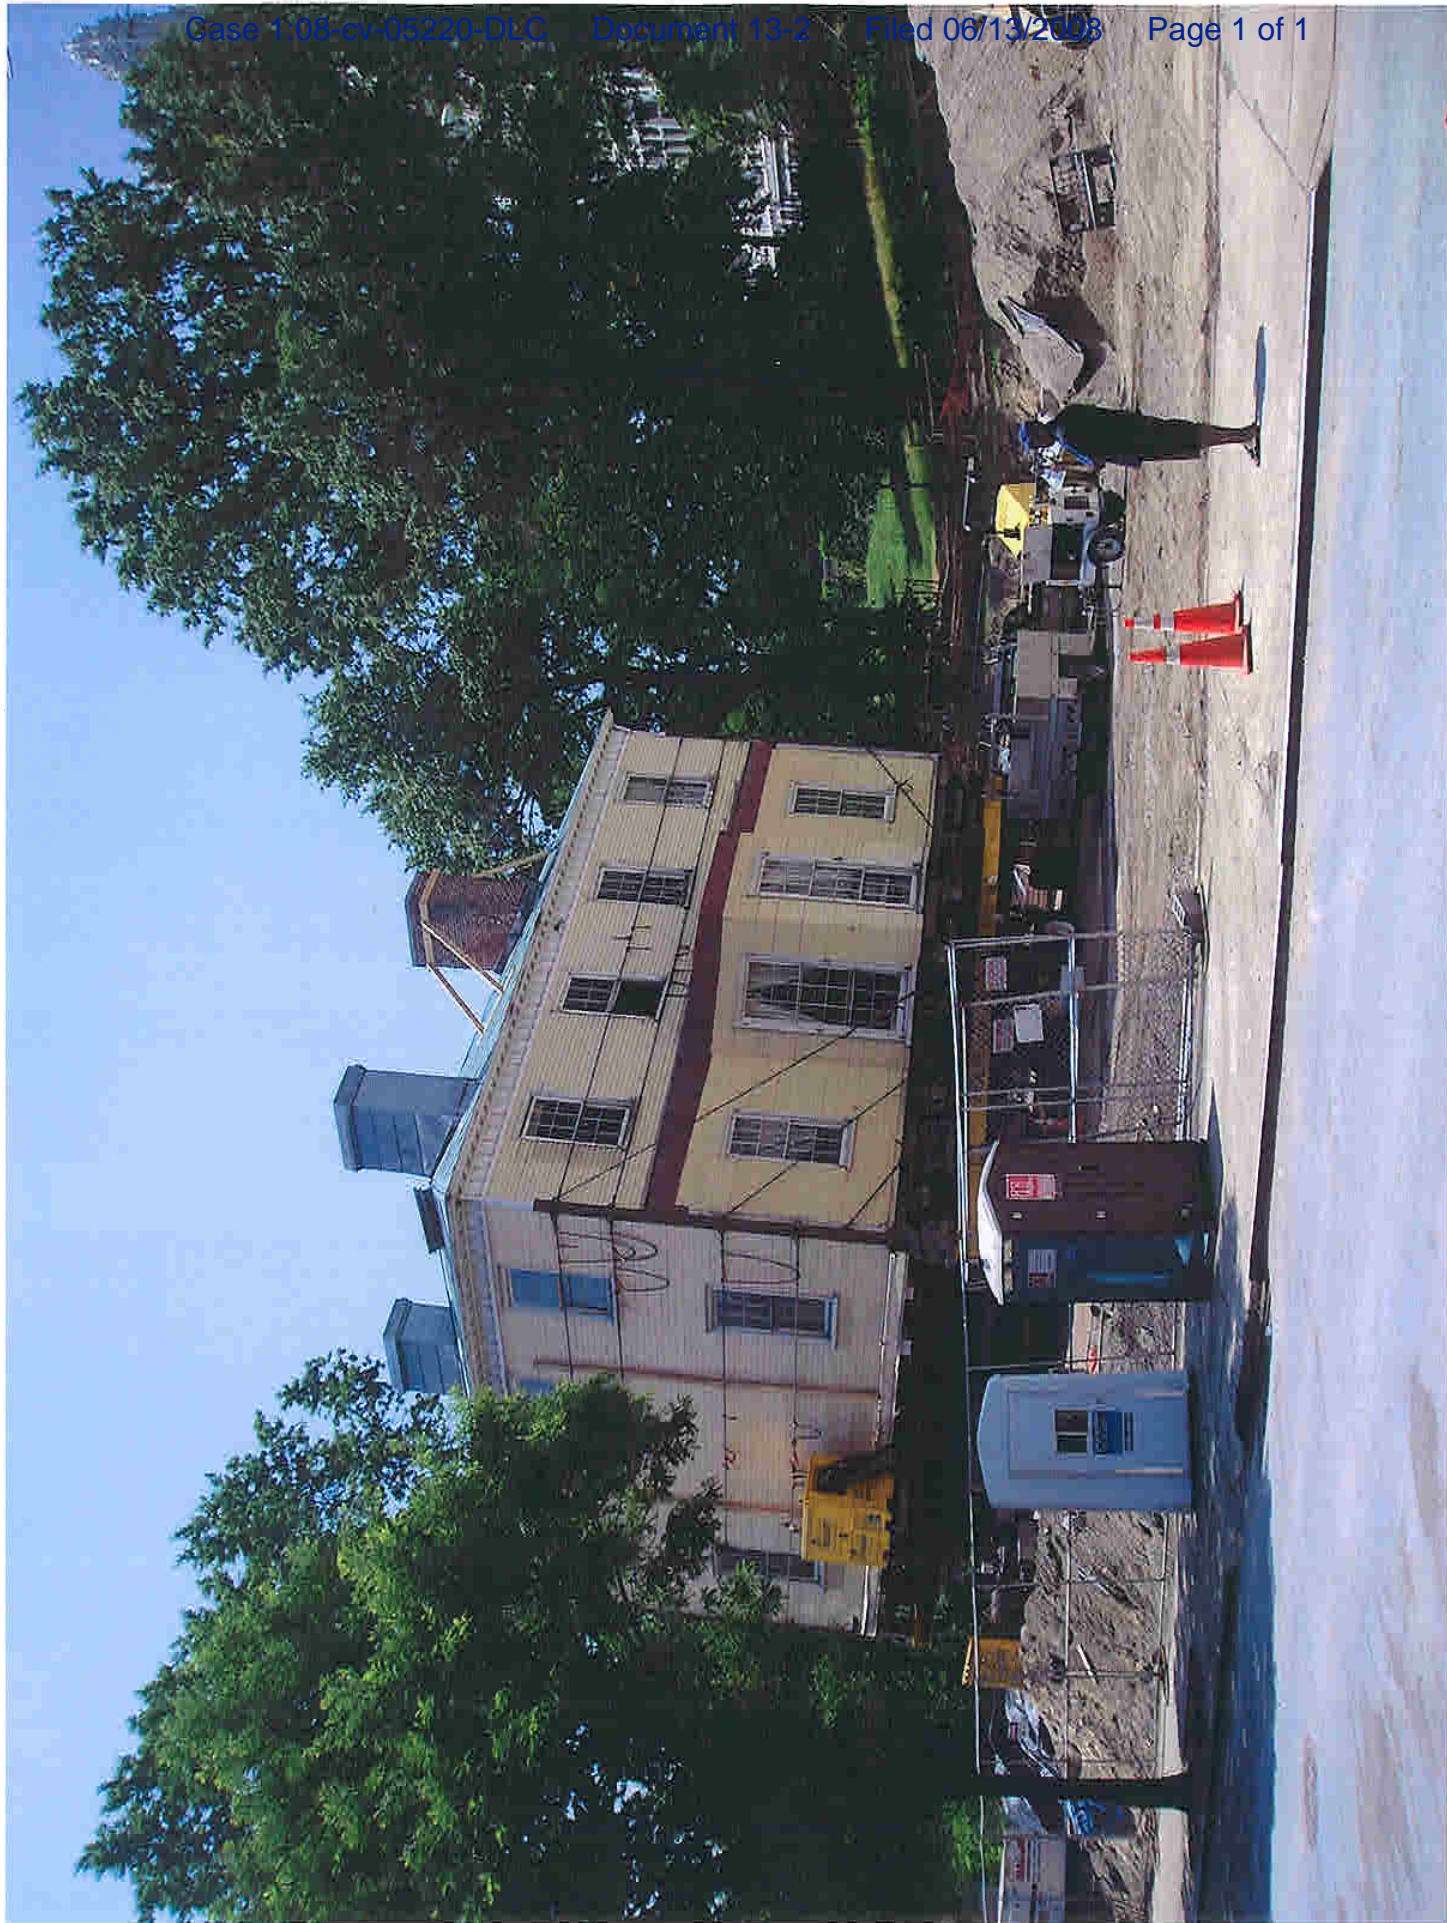
5. The Grange is currently located on a temporary support in St. Nicholas Park while the permanent foundation is completed. A photograph attached as Exhibit 1 and labeled USA 25 shows the Grange in St. Nicholas Park as it is currently situated. Unlike a permanent foundation, which provides continuous support to building sills load bearing walls, the temporary support provides only point loading, or support with blocking at intermittent locations of the structure. This blocking is in turn supported by wooden towers (called "cribbing") which support steel beams and the wood blocking. A photograph attached as Exhibit 2 and labeled USA 41 clearly shows the current point loading support. The Grange is currently situated on top of a 70 foot by 70 flat table of compacted gravel fill covered with one inch steel plates. These plates can be seen in the photograph attached here as Exhibit 1. The gravel mound upon which the Grange is currently located can be seen in Exhibit 2.

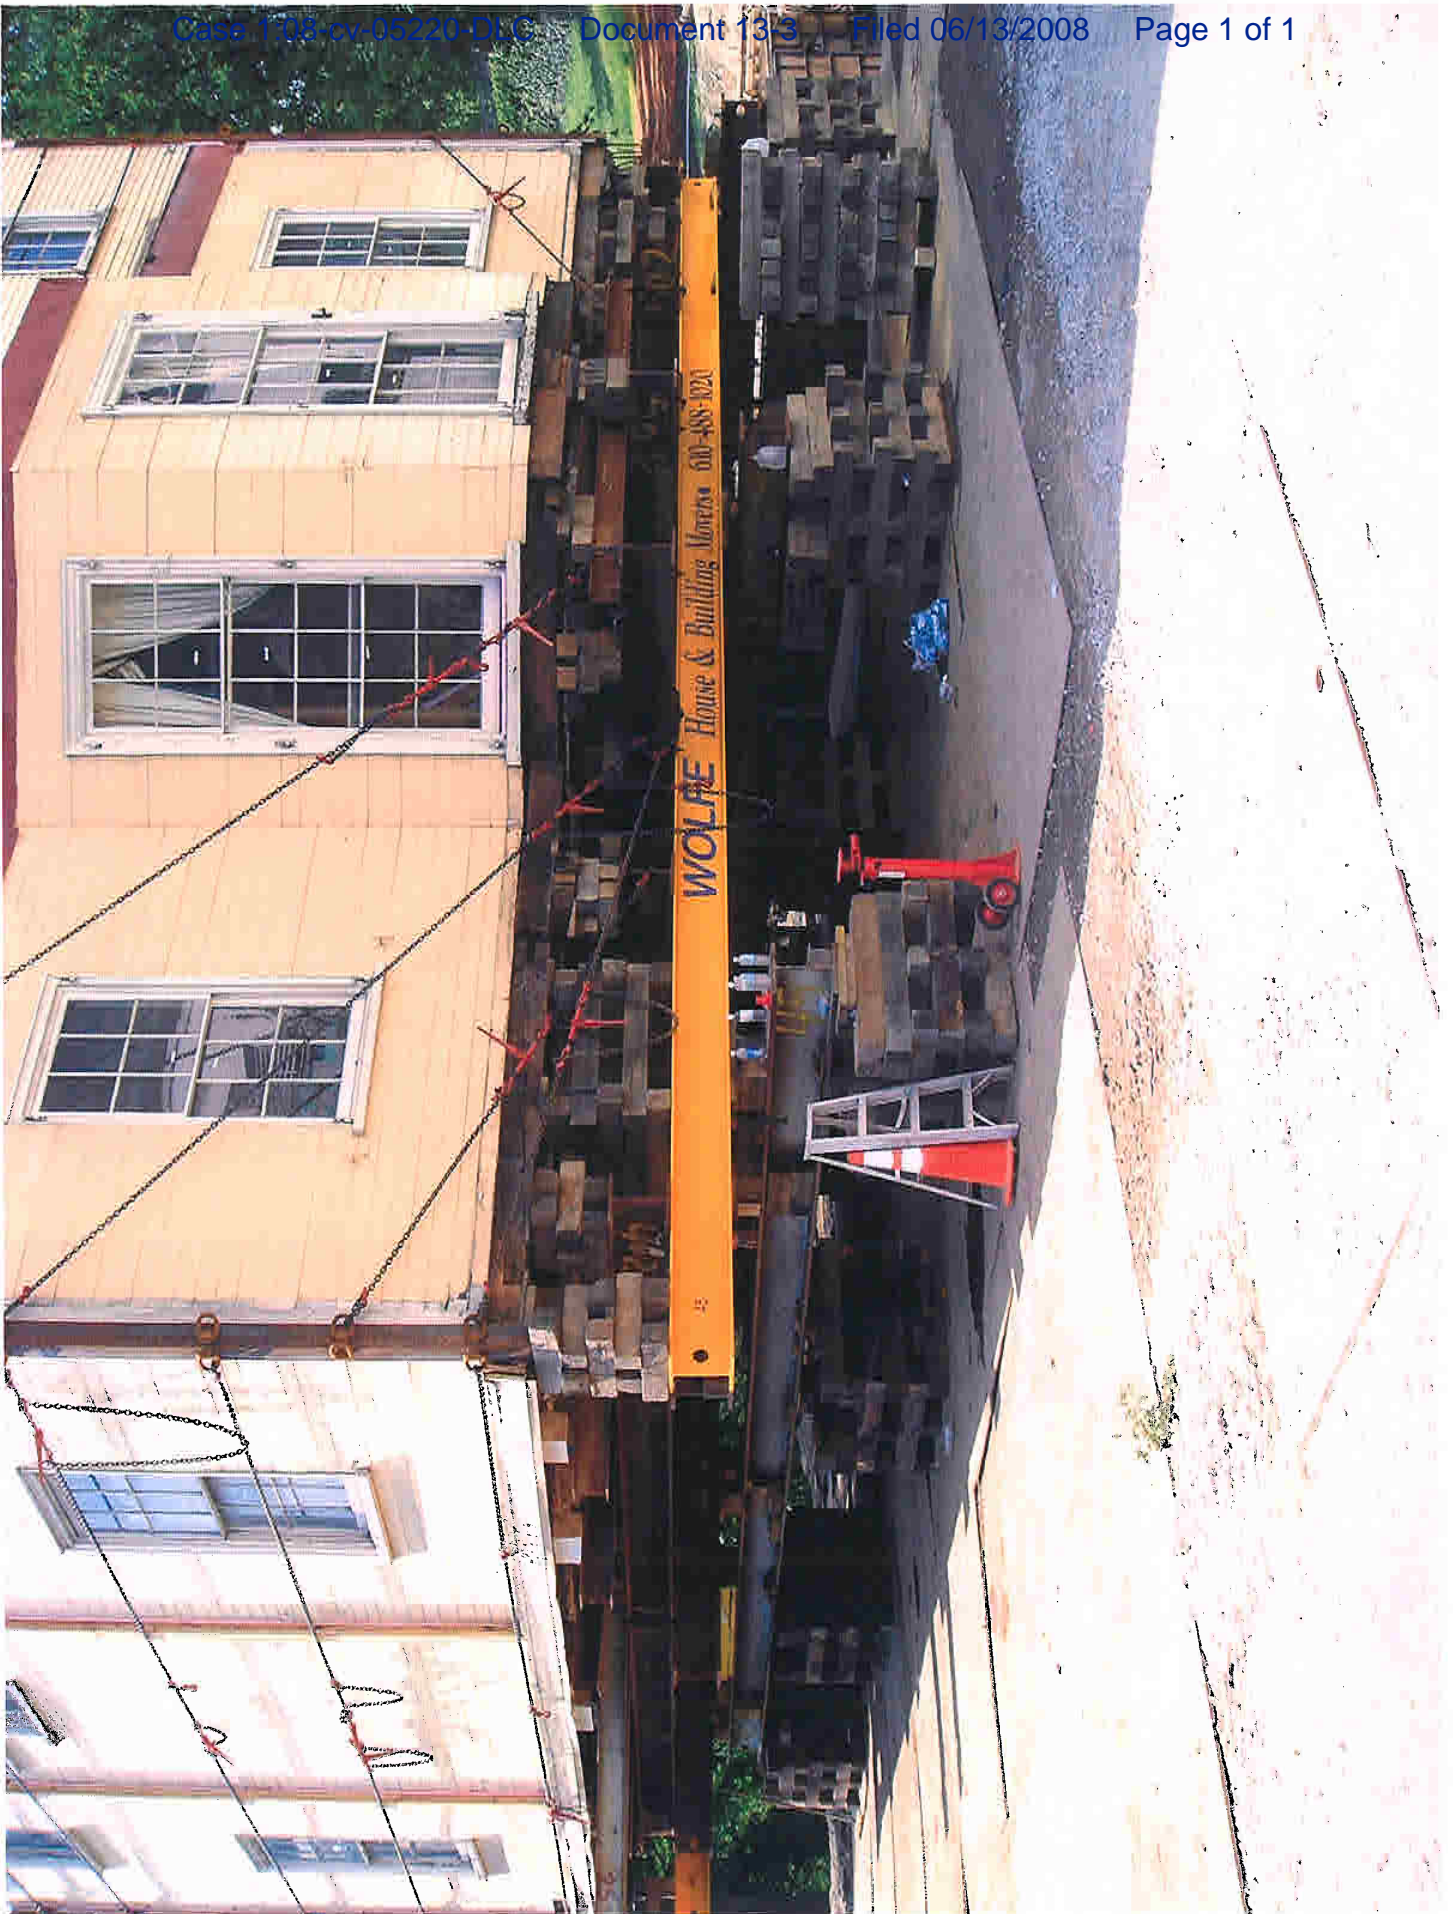
intended to be a temporary turning table and transition point for the Grange onto the permanent foundation. As such, it lacks adequate drainage to ensure stable support of the building for very long. As the soil becomes wet from rain or underground springs running through the site, areas of soil will settle differently, creating uneven support for the Grange.

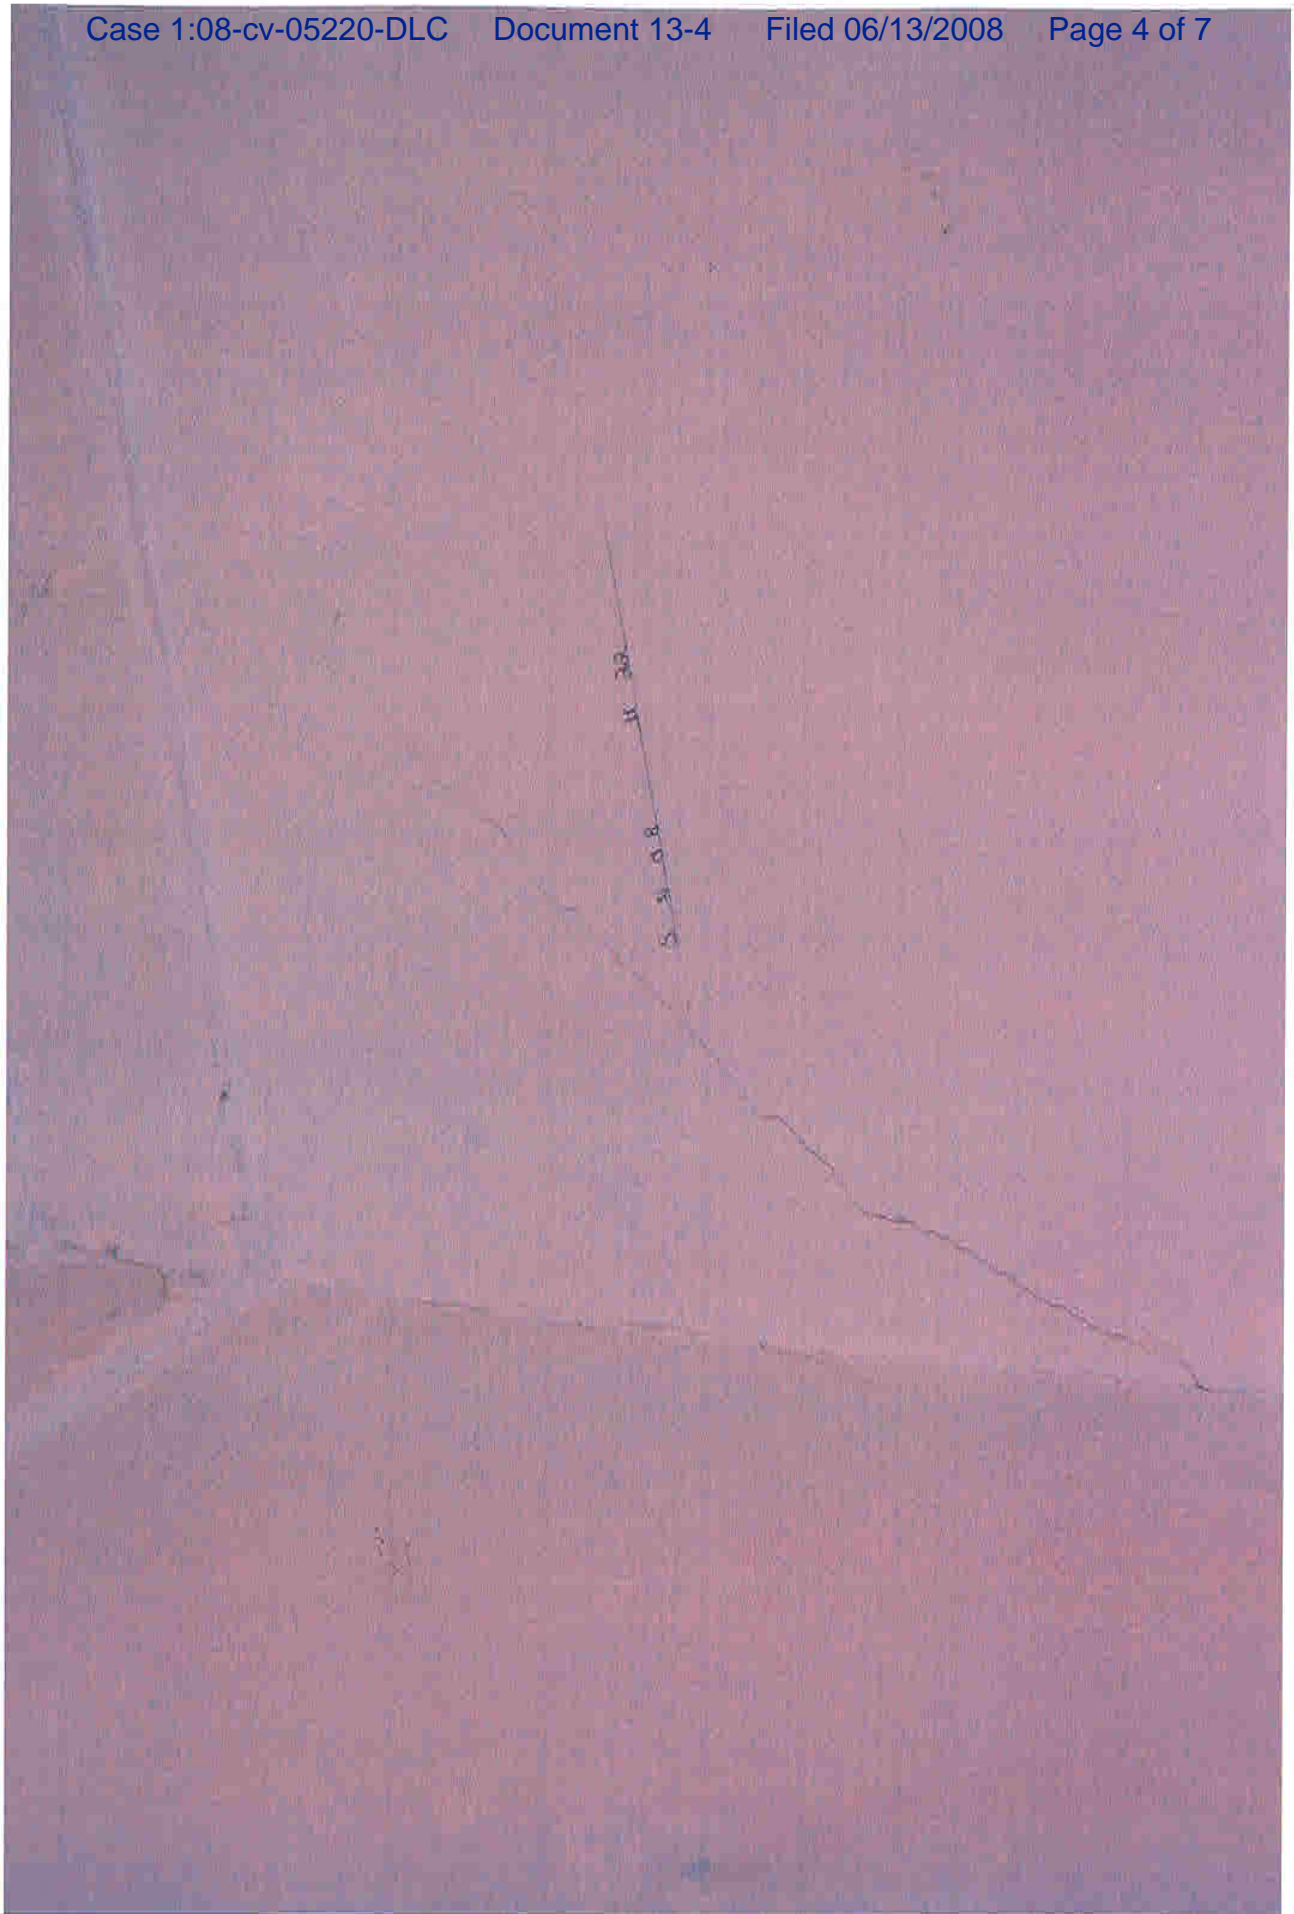
7. Cracks have formed in the plaster walls of the Grange. These cracks have formed and grown in response to the movement of the house from a uniform, continuously supportive foundation to point loading of its temporary foundation, first on Convent Avenue and currently in St. Nicholas Park. I have personally observed newly formed cracks along nearly every interior wall on the first floor of the Grange. On May 31, 2008, I personally inspected the Grange and had markings made to document the length of various cracks. On June 5, 2008, I again inspected the Grange and found the cracks in the plaster had grown considerably. Attached to this declaration as Exhibit 3 and labeled USA 47-53 are photographs taken during this June 5, 2008 visit. In each of these photographs, the cracks extended beyond the lines drawn on May 31, 2008, which indicated the termination of the crack on that date. Photographs labeled USA 51 and USA 52 show that the cracks are forming and growing in multiple directions. These cracks were first identified while the Grange was sitting on its temporary support on the road bed of Convent Avenue, a more stable location than the gravel platform where it is currently located.

8. I also personally inspected the Grange on June 11, 2008, subsequent to its relocation to St. Nicholas Park. I found that the cracks had continued to grow. Additionally, I discovered that a panel of plaster wall has bowed out from the wall.

9. These cracks and bowing are caused by the Grange's current position on point loaded blocking and the amount of deteriorated and compromised components of the wooden framing of the building which has resulted in the cracking and crushing of the plaster, wooden trim, and other aspects of the historic fabric in the Grange.

11. Cracks and bowing have damaged the historic fabric of the Grange and indicate that settlement is putting stress on the building. Cracks radiating in multiple directions indicate that the building is settling unevenly in a variety of directions. These cracks indicate threats to parts of the Grange that are more difficult to access visually, including the structural integrity of the building's wooden frame. The longer the Grange remains on the temporary foundation, the more damage to the historic fabric, both clearly visible and not, will occur. The only way to ensure the damage to the historic fabric ceases is to place the Grange on the uniform support of its permanent foundation.
